**Town of Avon Traffic Calming Program**

**Traffic Investigation Report**

**Cobblestone Springs Subdivision**

**March 11, 2008**

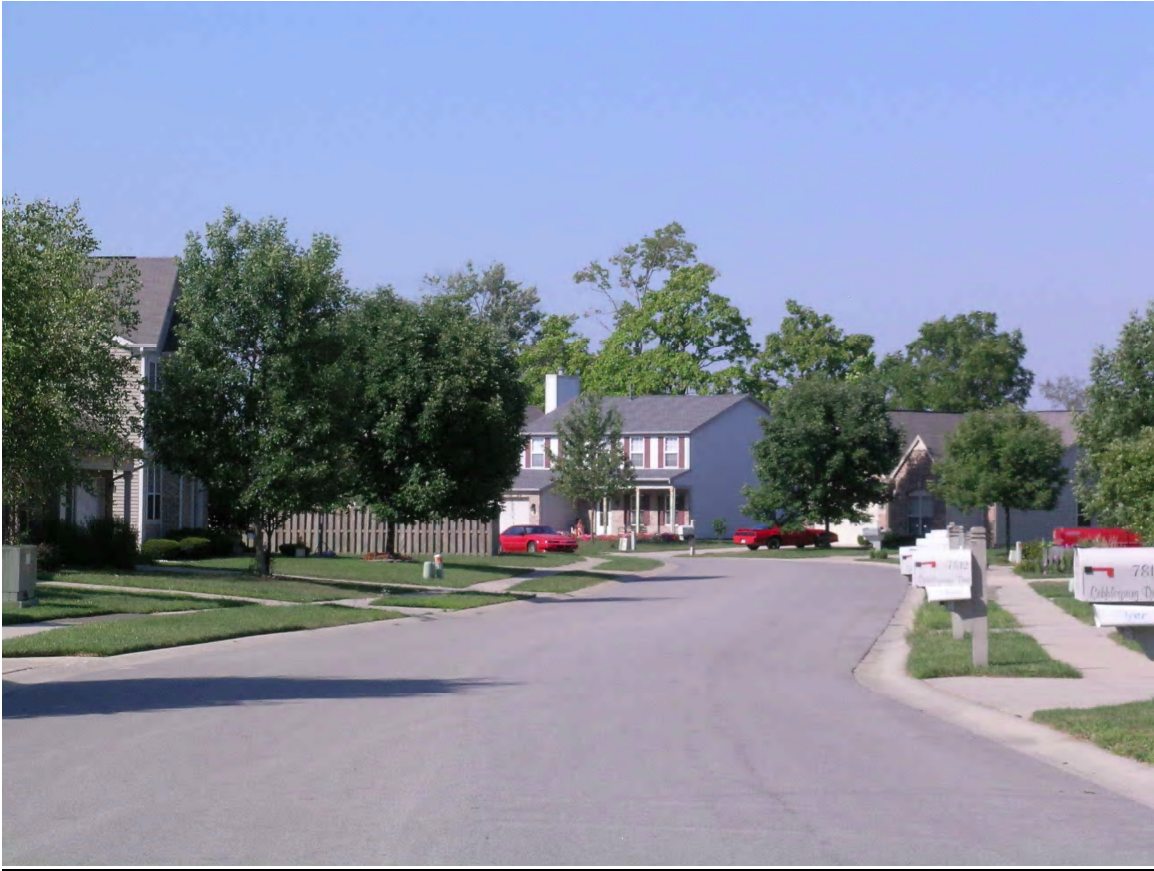
The traffic investigation focused on the cut-through street traffic between Dan Jones Road and US 36. Three streets were examined; Cobblestone Springs Drive, Red Sunset Court, and Springwood Drive.

Cobblestone Springs Drive serves as a residential or neighborhood collector street since it collects traffic from the side streets and cul-de-sacs and provides access to secondary arterial roadways. There are two relatively straight street sections on Cobblestone Springs, and all three streets are relatively wide with provisions for on-street parking. Sidewalks are located on both sides of the three streets.
